ANDROSCOGGIN RIVER BASIN
RUMFORD, MAINE

**MOUNT ZIRCON RESERVOIR DAM
ME-00244**

**PHASE I INSPECTION REPORT
NATIONAL DAM INSPECTION PROGRAM**

OCTOBER 1978

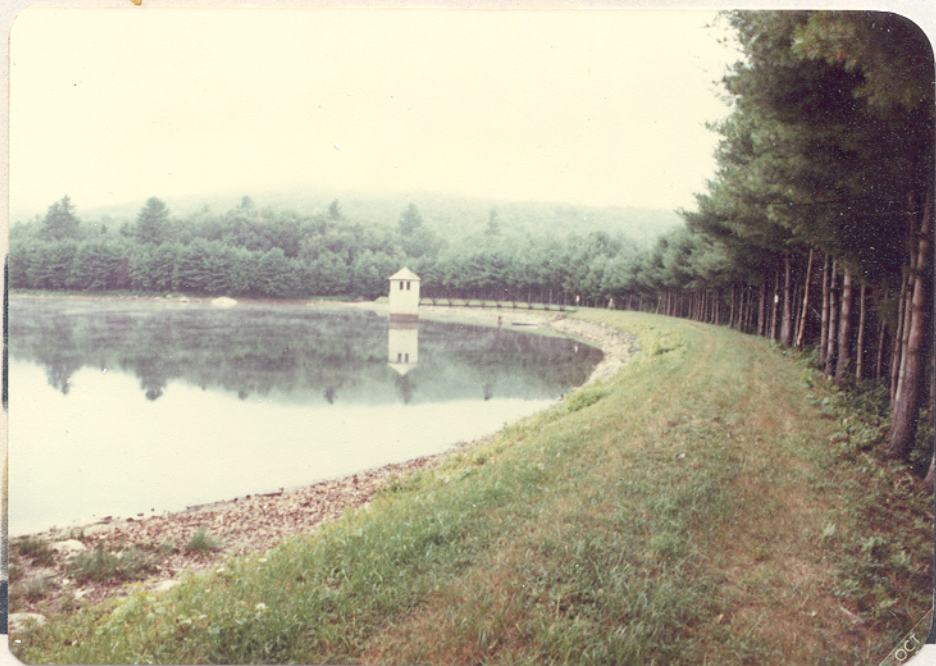
1

VIEW OF DAM FROM EAST END

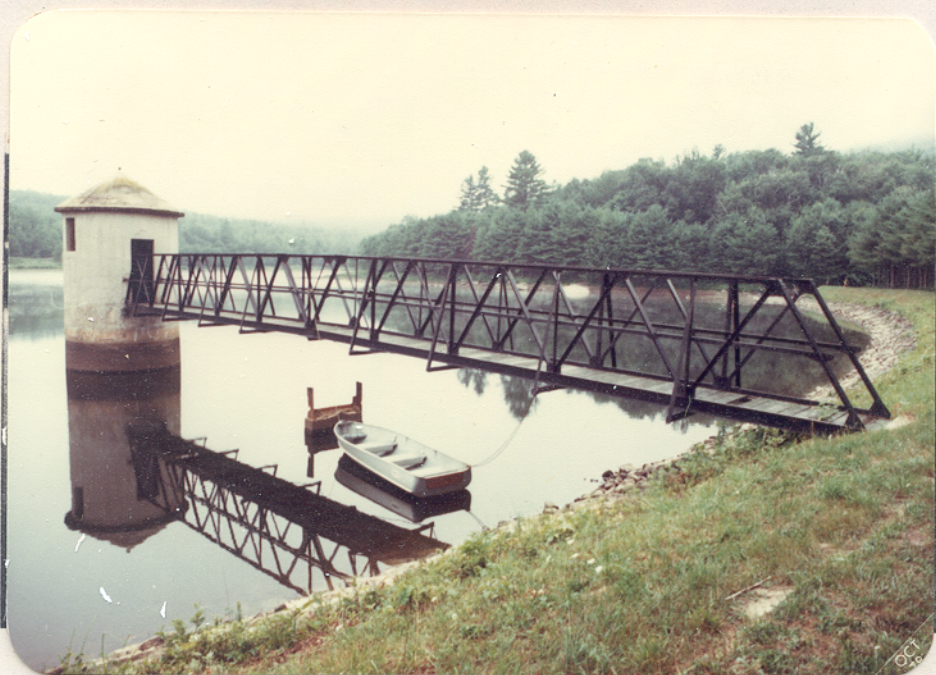
2

- a. Concrete Surfaces. Except for the zone from about elevation 835 to 840 the concrete surface of the gate house is good. Within the zone from elevation 835 to 840, the exterior surface is spalled to a depth of 1 to 3 inches. The area has been previously repaired and since spalled again.

CONTROL GATE HOUSE

5. The spalled concrete on the sidewalls of the gate works should be repaired.
6. The condition of the riprap slope protection should be examined at least once each year and whenever the reservoir level is low enough to permit direct observation. Repairs should be scheduled if conditions warrant.

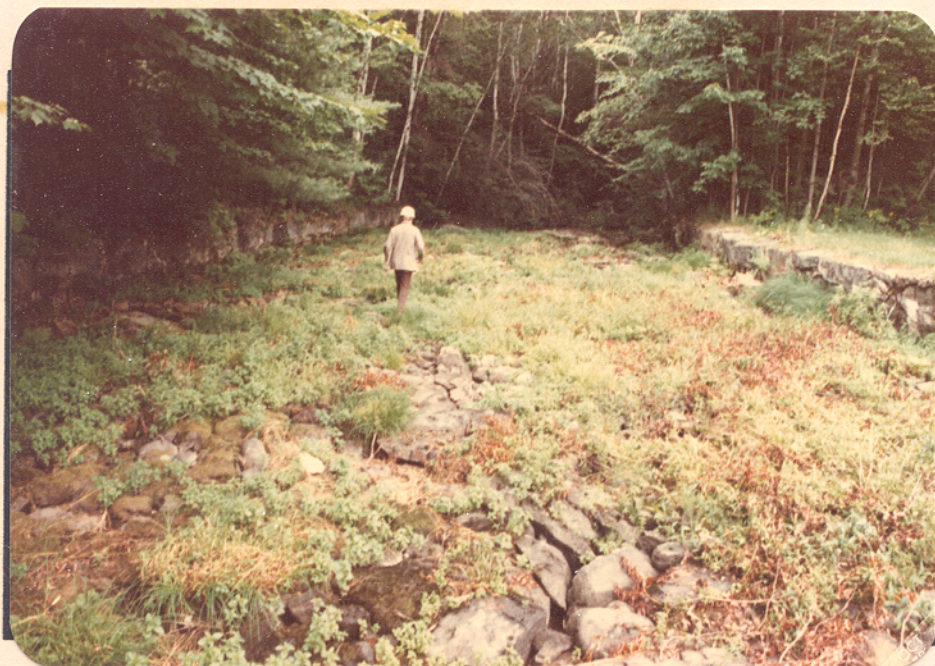
3

d. Stilling Basin. Below the spillway crest is a channel paved with stone which is in good condition. One small cavity was observed. See Photograph 3.

- d. Stilling Basin. No provision for preventing erosion was noted below the 24-inch outlet. Rip rap is shown on the drawings but none was observed.
- e. Approach and Outlet Channels. The approach is not visible due to water levels. The outlet channel is lined with brush and small trees, as shown in Photograph 3.

SPILLWAY DISCHARGE CHANNEL

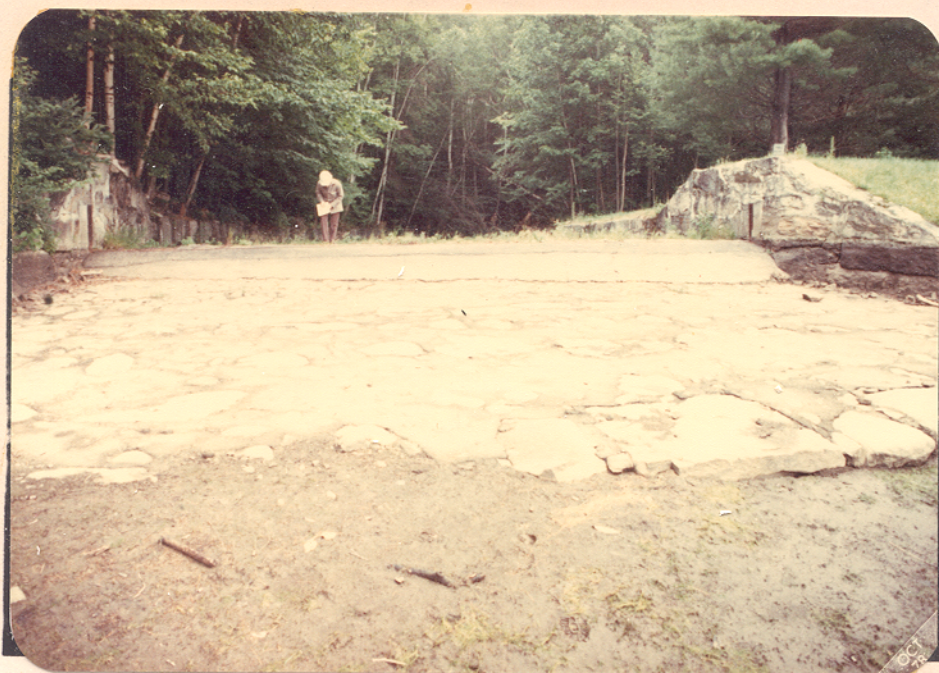
4

- (g) The stone masonry spillway is in generally good condition, however the sidewalls have tipped toward the center of the spillway. A small stone lined cavity exists in the outlet channel. The masonry has been pointed but some cracks exist.

SPILLWAY

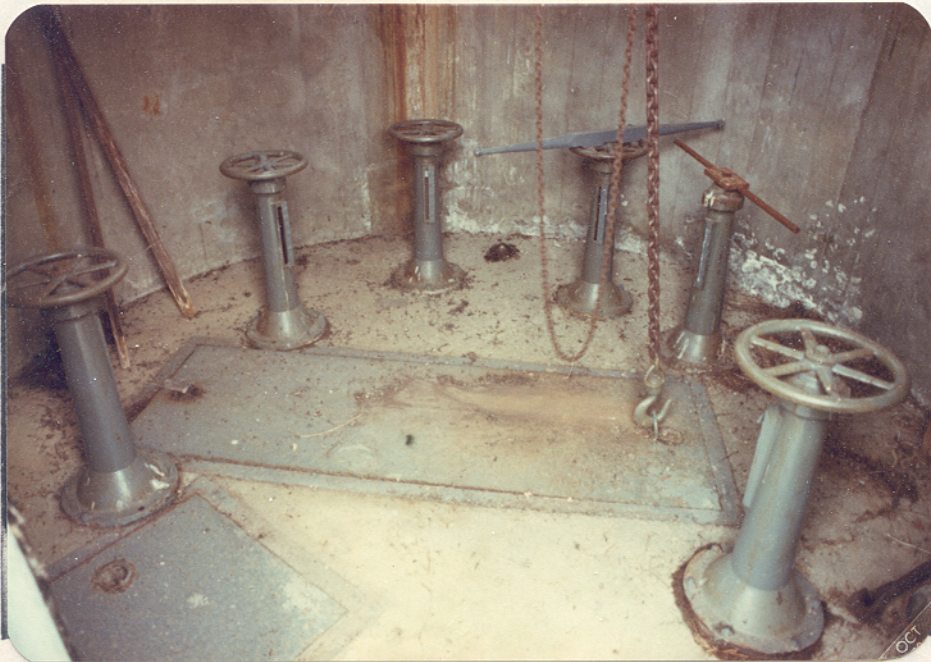
5

Mechanical equipment at the dam consists of gate valves and manual operating equipment, and a hoist for moving the screens in the gate house. The hoist was operated and is in good condition. The gate valves were not operated, but except for the 24-inch blow-off line, the gate valves are operational and are used as necessary for water supply.

GATE CONTROL MECHANISM IN GATE HOUSE

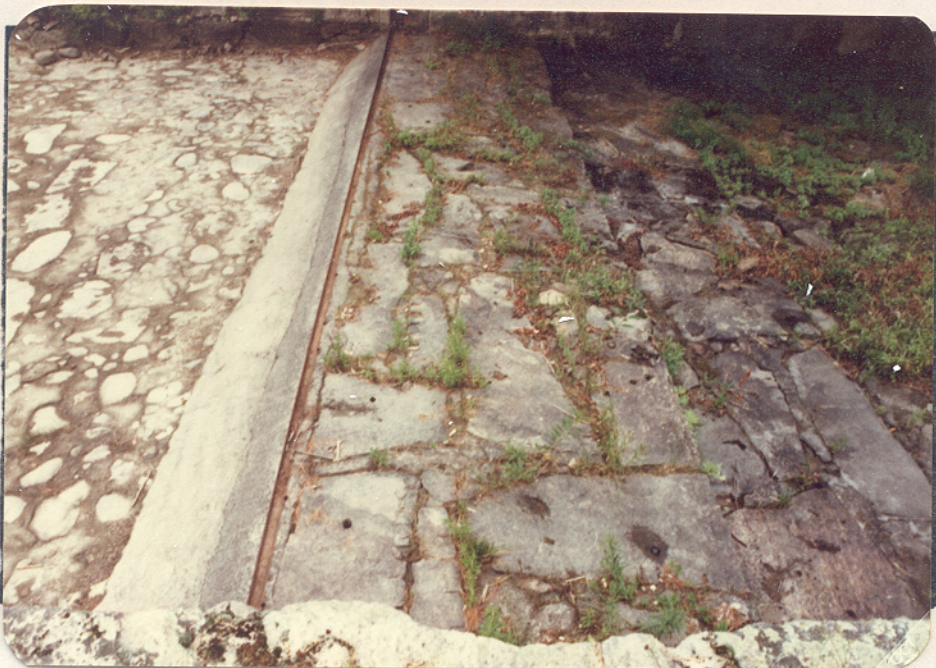
6

- f. Water Passages. The surfaces of the masonry spillway show no signs of erosion, leakage, or significant structural cracking. One small cavity (stonelined) exists just below the spillway crest.

SPILLWAY CREST

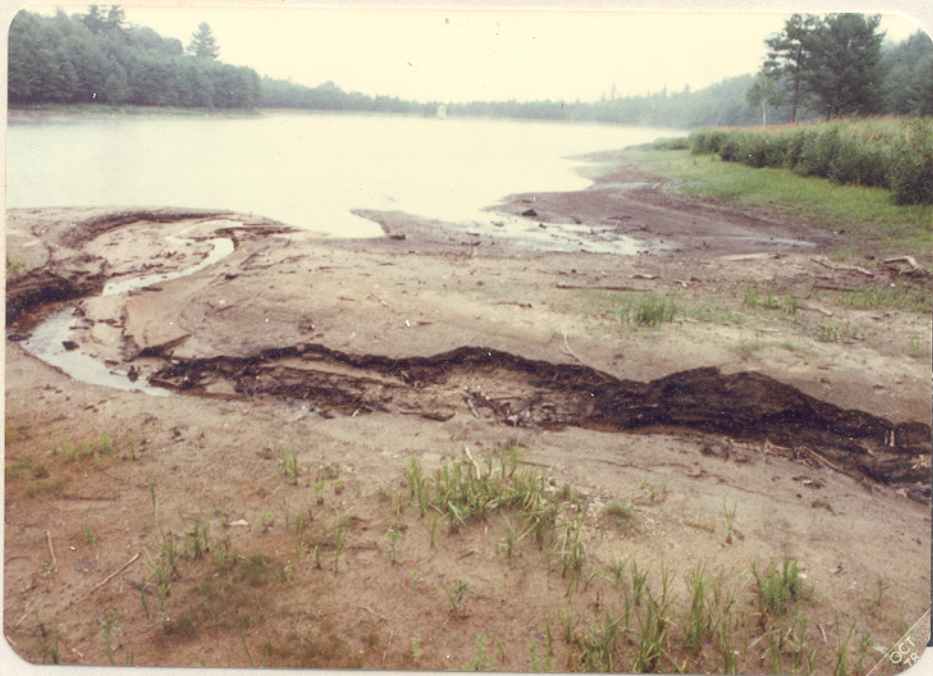
7

- a. Shore Line. No major active or inactive landslide areas on Mount Zircon Reservoir were observed.
- b. Sedimentation. The watershed has remained essentially rural. There are no new developments or new sources of sediment loads on the reservoir. However, sediment at least 2 feet in depth covers the southerly shore of the reservoir at the inlet end, as shown in Photograph 7.

SILT DEPOSITS AT INLET TO RESERVOIR
